This spreadsheet performs screening level calculations to estimate the effect of peeling leaded paint on the average concentration of lead in yard soil

3522 Marion Street

Property ID:	2659
Address: 3522 MARION STREET	Date: 7/5/05
Owner:	Telephone #:
Inspector/Assessor: STRATO	CO Certification #: 12860
Plot Plan:

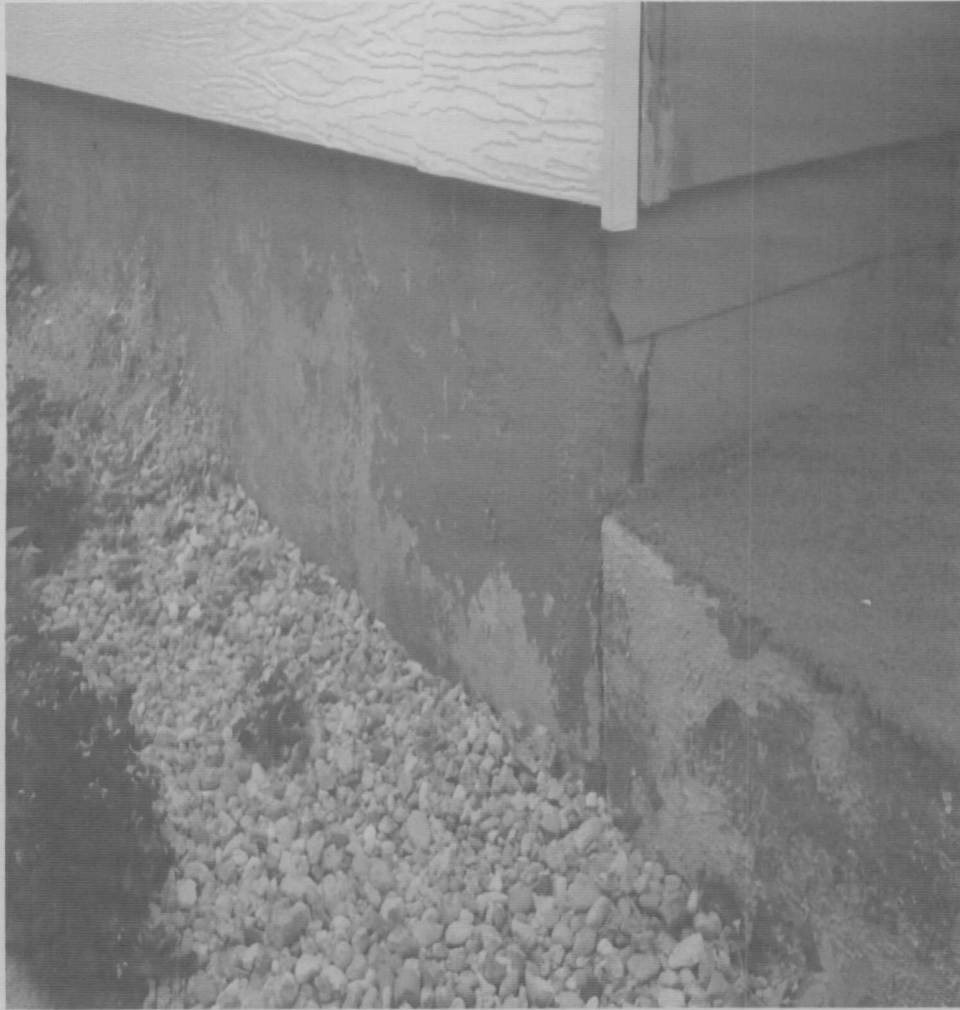
Property # 2659

Exposed foundation on north & south side of property contain lead paint & are peeling

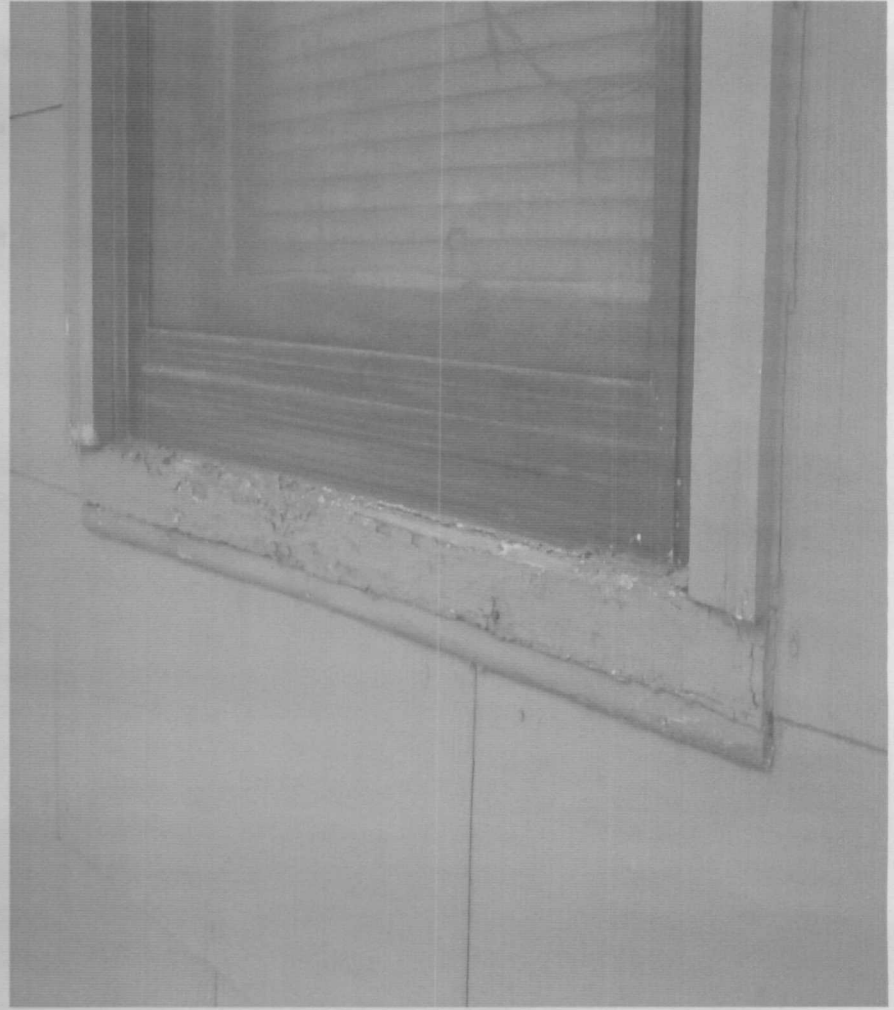
Wood window trims contains lead paint & are in peeling condition

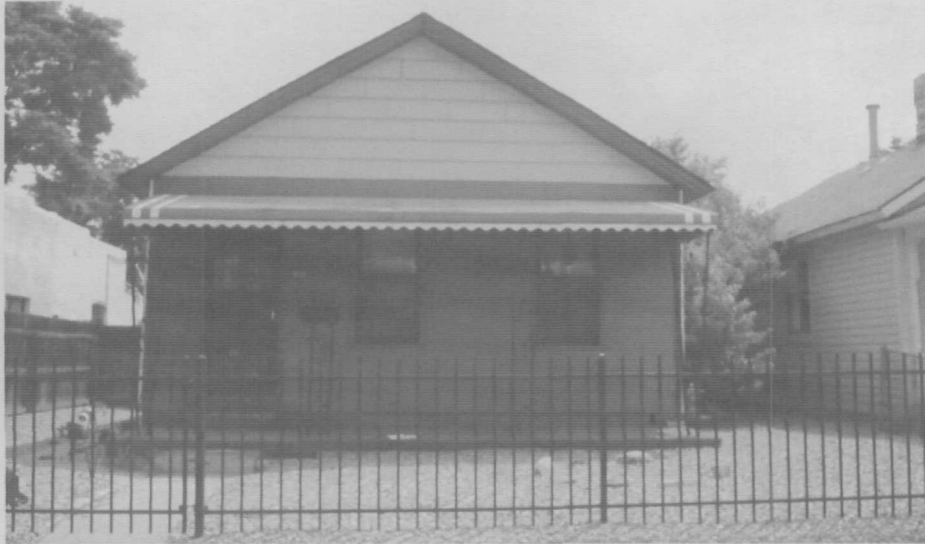
Property # 2659 / 3522 Marion Street

Wood trim & eaves contain lead paint & are peeling
